Alert Service Bulletin No. 048 Rev. 3

**Turbocharger TA0411
P/N 410188-0019 Turbine Wheel Replacement**

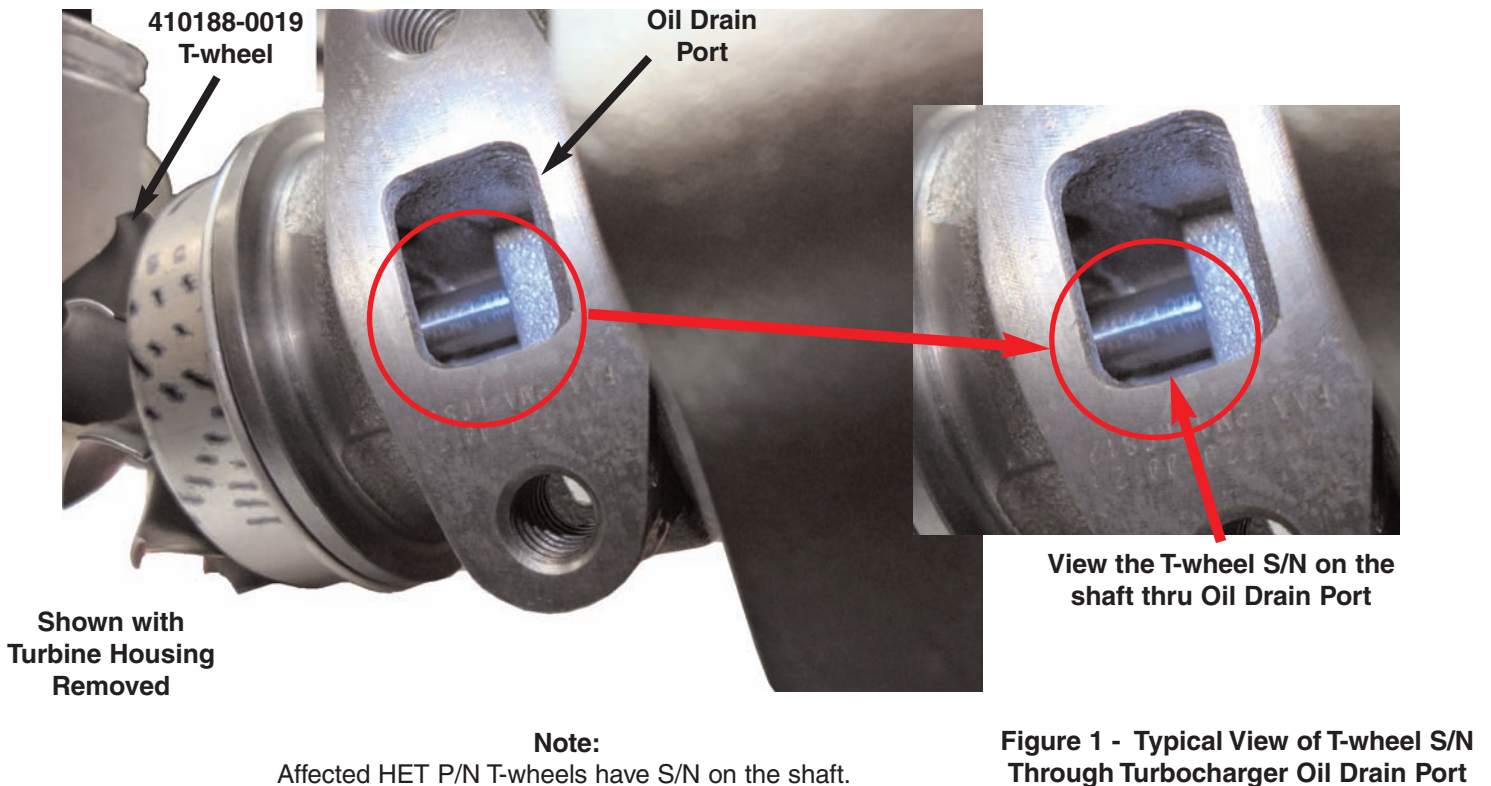
- (b) If the serial number **is listed** in Table 2, continue with Corrective Action 3.B(1).
 - (c) If the turbocharger was overhauled or repaired between August 29, 2012 and November 16, 2012 and the HET P/N 410188-0019 T-wheel was replaced, then determine if the serial number etched on the T-wheel shaft is affected. This may be done by removing the oil drain fitting and with adequate lighting, observing the shaft. (see Fig. 1).
