TURBOCHARGER INSPECTION AND REPLACEMENT

REASON FOR REVISION: To revise the serial number effectivity list by adding S/N KCN01116.

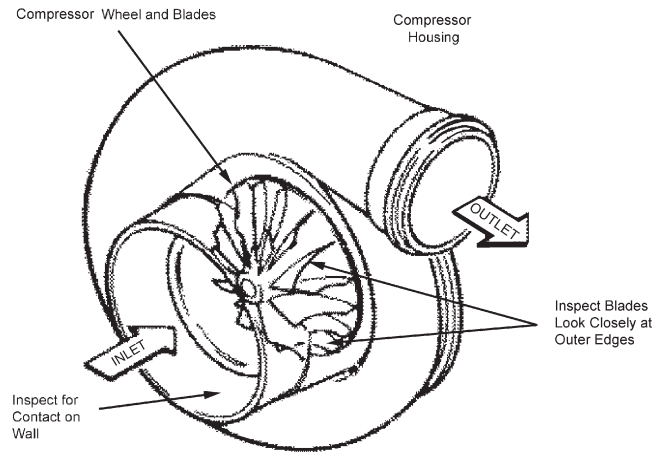
Figure 2 - Turbocharger Inspection Points

3. Visually inspect each turbocharger through the compressor inlet for any signs of contact. Look for witness marks from the impeller wheel, giving careful attention to the outer edges of the wheel blades and the inner wall of the compressor housing. Contact marks on the housing from the wheel will appear as a burnishing on the inner wall. Grooves or gouges of any sort are cause for turbocharger replacement. Utilize supplemental lighting if needed to facilitate visual inspection.

4. If any anomalies are noted during the visual inspection, replace the turbocharger. If nothing appears in the visual inspection, the turbocharger is suitable to submit for a ferry permit. This will allow the aircraft to be relocated to qualified facility for turbocharger replacement.
