Service Bulletin

Bulletin No. 033

Issue Date: July 10, 2008

ES7024-11 (TCM P/N 656872) ES7024-14 (TCM P/N 657199) ALTERNATOR FAN AND PULLEY REPLACEMENT

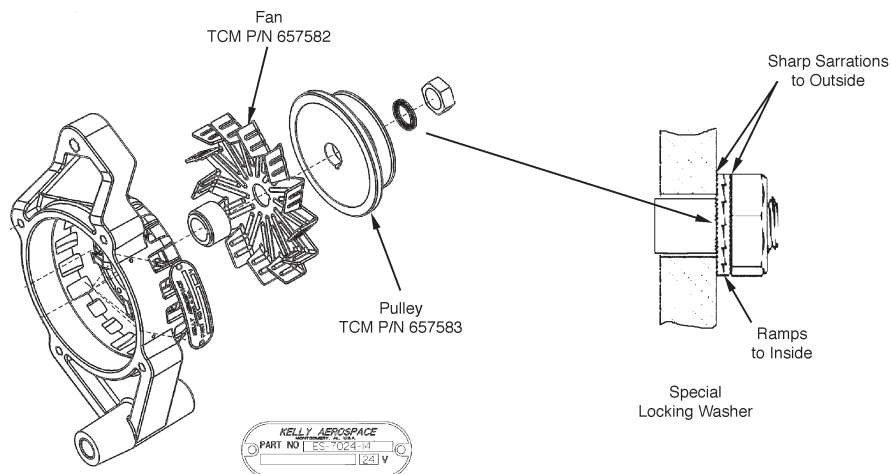
Figure 1 - Alternator Part Replacement

It has come to the attention of Hartzell Engine Technologies LLC (HET), that certain Cirrus Design SR22 airplanes may experience failures in the cooling fan of the backup alternator. During normal operation of the ES7024-11 (TCM 656872) & ES7024-14 (TCM 657199) backup alternator, a variable resonance condition with the cooling fan currently installed, may result in the development of cracks in portions of the blades. This condition, left uncorrected, may lead to the loss of the entire fan assembly with the potential loss of alternator function.

5. Install a new TCM P/N 657582 fan, and new TCM P/N 657583 pulley as shown in Figure 1. Use the existing pulley nut and the locking washer. Take care when removing the locking washer as it is a special device which has two pieces. The sharp serrations must face outward while the shallow ramp must face each other. Using the strap wrench per instruction 4 above, torque the pulley nut to 35 to 45 ft-lbs.
