Service Bulletin

No. 044

Alternator Recall for Installation of Improper Wave Retainer

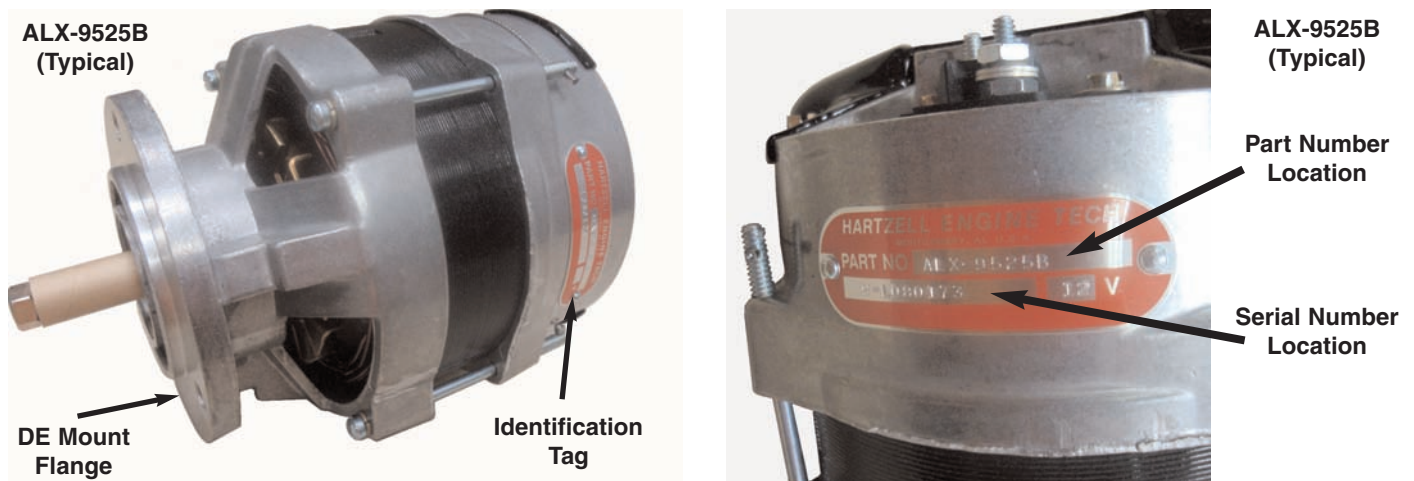
**Figure 1 - Typical ALX-9525B Gear Driven Alternator
(ALX-9525BR is the same except "R" indicates Rebuilt.)**
