Service Bulletin

Bulletin No. 045

201F Fuel Pump Inspection & Recall

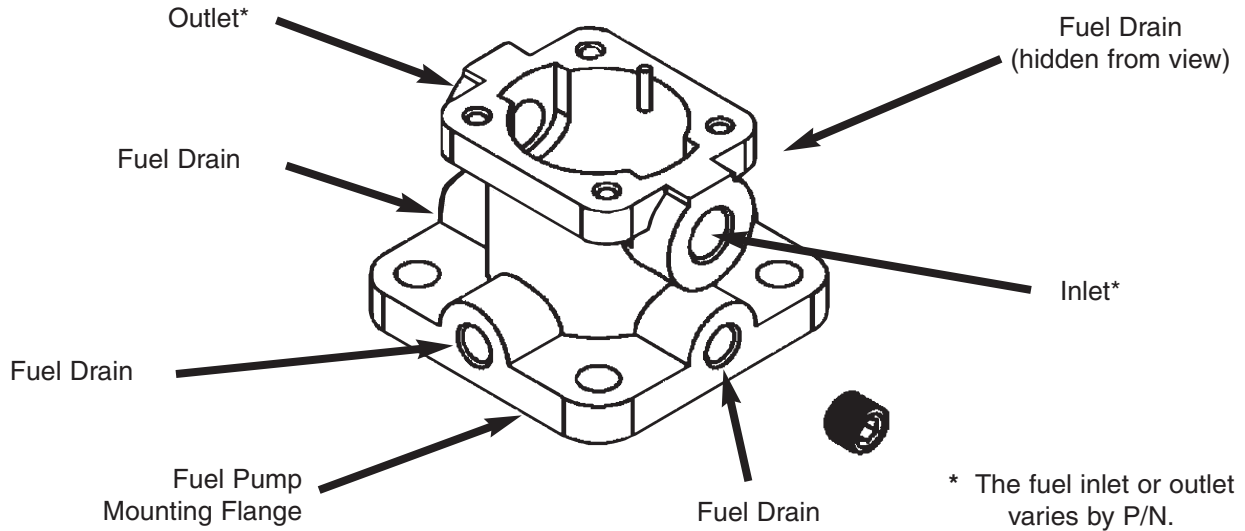
Figure 1 - 201F Inlet / Outlet & Drains (Typical)

- (3) A damaged shaft seal may result in a fuel leak which may lead to a loss of engine power and it may pose a fire hazard. Fuel will be routed to drain ports in the pump mounting flange where an airframe provided drain may be attached.

- (c) Observe the overboard drain for fuel leakage. If leaking, turn off immediately.
 - (d) Most fuel pump overboard drains are located on the bottom cowl near the firewall. However, check with the specific AFM, POH, or maintenance manual for the aircraft for proper location.

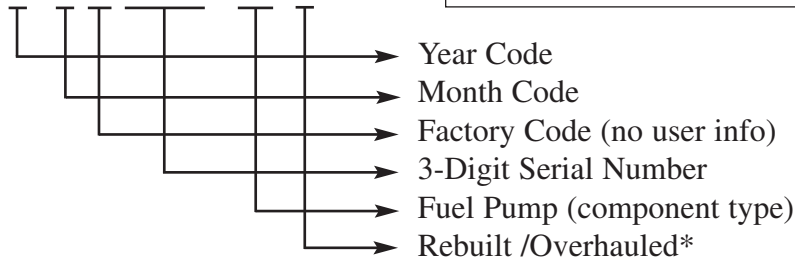
Figure 2 - 201F Serial Number Breakdown

- (1) Hartzell Engine Technologies LLC (HET) 201F Series Fuel Pump P/N's 201F-5001, 201F-5002, 201F-5003, 201F-5004, 201F-5005, 201F-5006, 201F-5007, and 201F-5008 as used on Lycoming engines listed in Table 1* of this service bulletin.
 - (a) Fuel pumps with serial number up to and including H-PBN065FP are affected. These fuel pumps were manufactured between January 2002 and February 2012.
 - (b) Fuel pumps with serial number H-PCN025FP and up are not affected. (Refer to Fig. 2)
 - (c) An affected fuel pump may be new, rebuilt, or overhauled.

Year Code	N = 2010, O = 2011, P = 2012, etc.
Month Code	A = January, B = February, C = March, etc.
Serial Number	3-Digit Sequential Number
