Service Bulletin No. 053

Alternator HET P/N ASG12000 (-1, -2, & -3)

Housing Gap Check

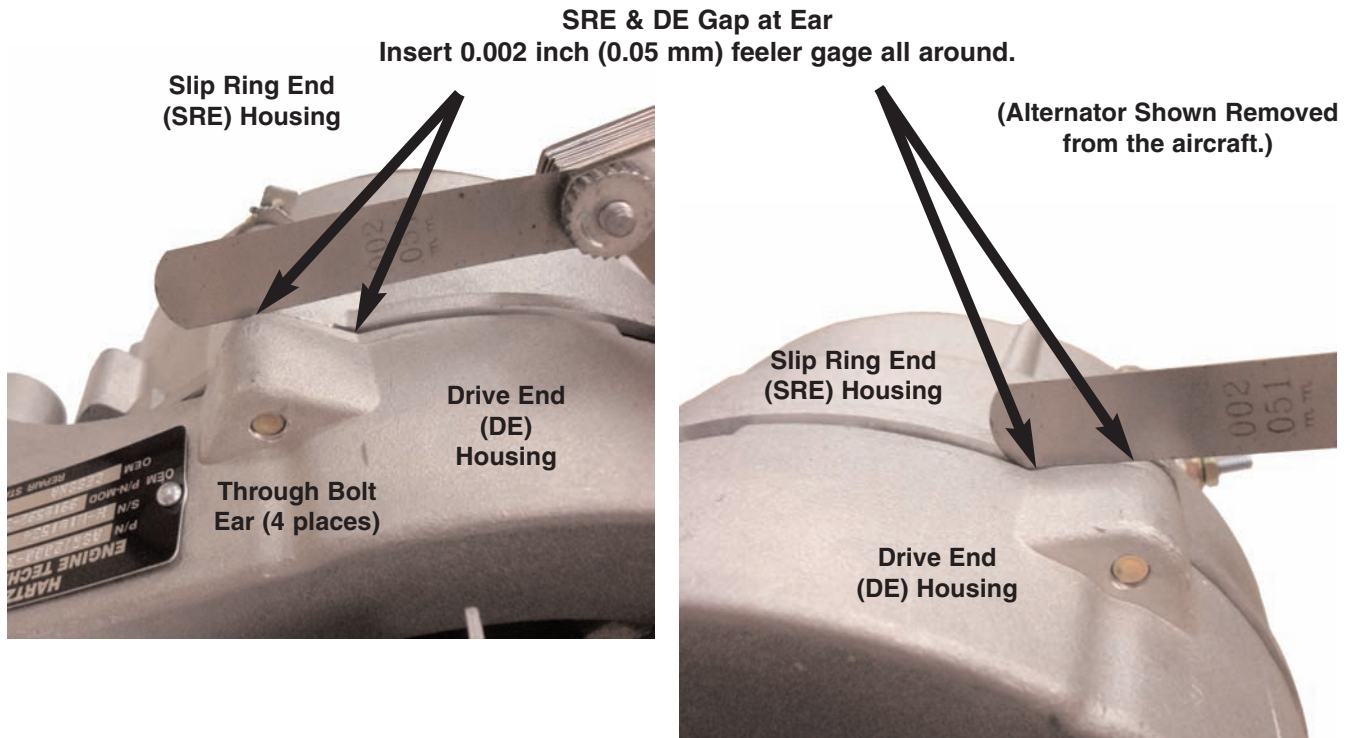
- (1) Hartzell Engine Technologies has discovered that a group of HET P/N ASG12000 (Cessna P/N 9910592) alternators may have an interference condition between the drive end housing and the slip ring end housing.
- (2) This condition may prevent proper retention of the stator assembly which may allow the stator to contact rotating components. Moderate to severe contact may disable the alternator.
- (3) This condition may appear in alternators manufactured between first unit of January 2010 and the first unit of March 2013 (see Table 1).
- (4) Notify Cessna Aircraft of the alternator condition and effectivity.
- (5) Regulatory action is not expected.

- (a) Figure 2 shows an unacceptable feeler gage check with no gap at each ear.
 - (b) Figure 4 shows an acceptable feeler gage check with proper gap at each ear.

Figure 2 - SRE & DE Housing Shown With Interference at Ear.
0.002 inch (0.05 mm) Feeler Gage Will Not Fit
(Alternator Unacceptable)

- (2) If the 0.002 inch (0.05 mm) feeler gage will not fit at any location around the ear as shown in Figure 2, the alternator must be removed.
 - (a) Remove the affected alternator in accordance with applicable engine and/or Cessna Aircraft Maintenance Manual.

- (b) Return the affected alternator to an authorized Cessna facility per instructions contained in the Cessna service publication of the same subject.

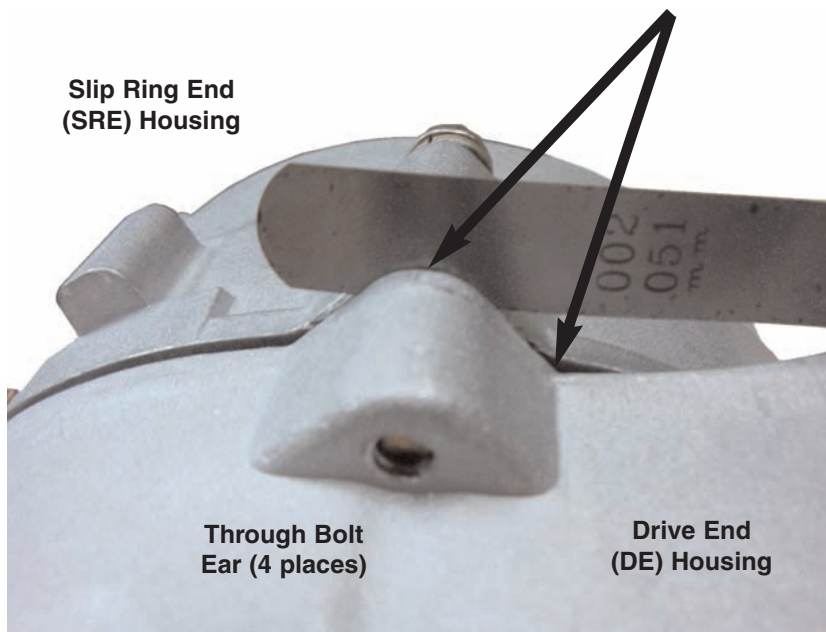
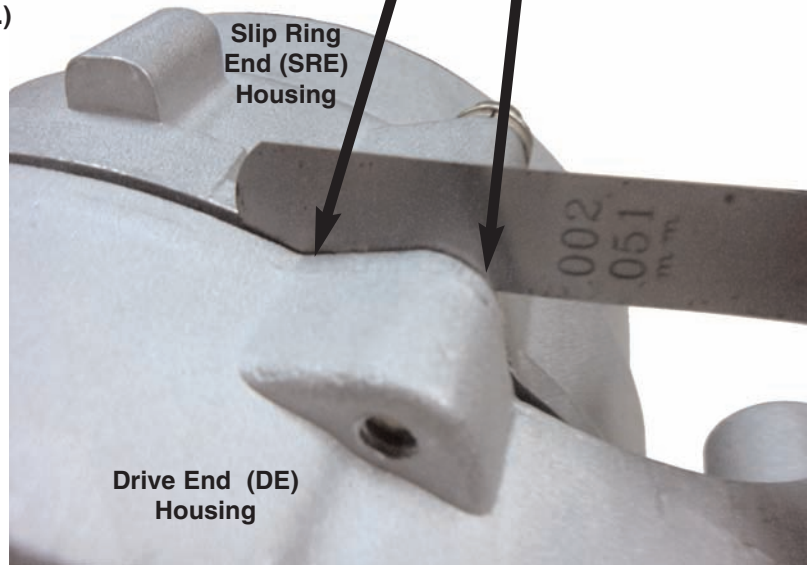
SRE & DE Gap at Ear
Insert 0.002 inch (0.05 mm) feeler gage all around.

**Figure 4 - DE & SRE Housing Shown
With Appropriate Gap at Joint.**

**0.002 inch (0.50 mm) Feeler Gage Fits
(Alternator Acceptable)**

- (3) If the 0.002 inch (0.05 mm) feeler gage fits at all locations around each ear as shown in Figure 4, the alternator is acceptable. Using a suitable tool, stamp an "A" on the nameplate after the affected serial number to indicate the alternator has passed the clearance inspection in 3.B.
