## Service Bulletin No. 059

### Alternator Inspection for Burrs in the Rotor Shaft Hex Key Socket

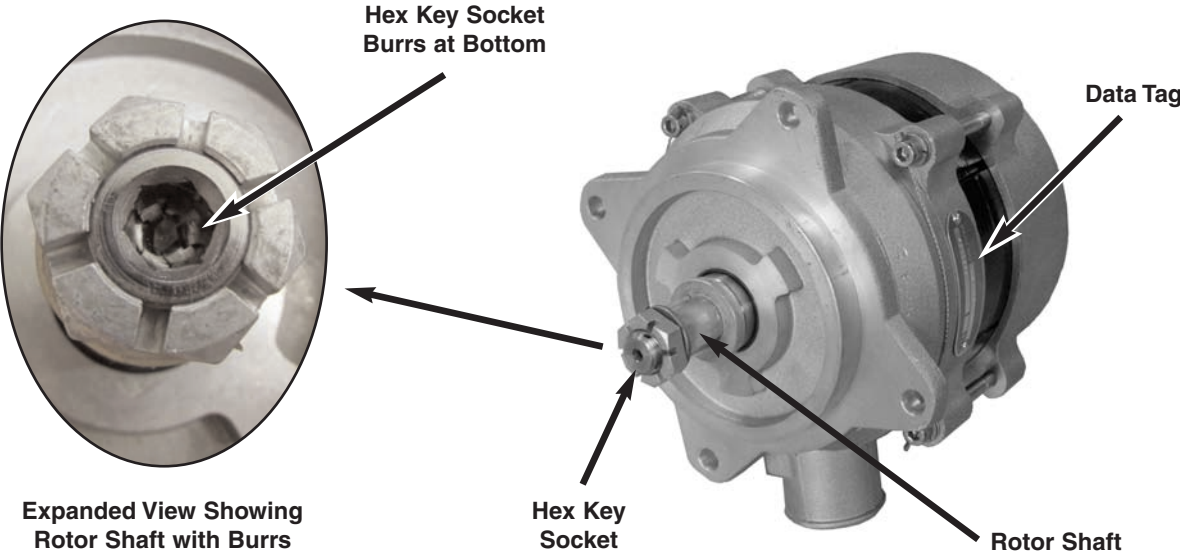
- (2) Using a bright white light, inspect the rotor shaft hex key socket for the presence of burrs. Refer to the expanded view of Figure 1. It is not necessary to remove the gear drive coupling, cotter pin, and nut (if installed ) for the inspection.
- (3) Burrs , if present, will appear as curled segments of metal at the bottom of the hex socket.
  - (a) If any burrs are present, proceed to section 3.C Corrective Action.
  - (b) If there are no burrs present in the rotor shaft hex key socket then:
    - (i) If installed, proceed to section 3.C(3).
    - (ii) If not installed, proceed to section 3.E(2).

Fig. 1 - Typical Alternator with Rotor Shaft Close-up  
ES-10024 (CMI 656802) Gear Driven Alternator Shown  
(Other alternators affected are similar.)

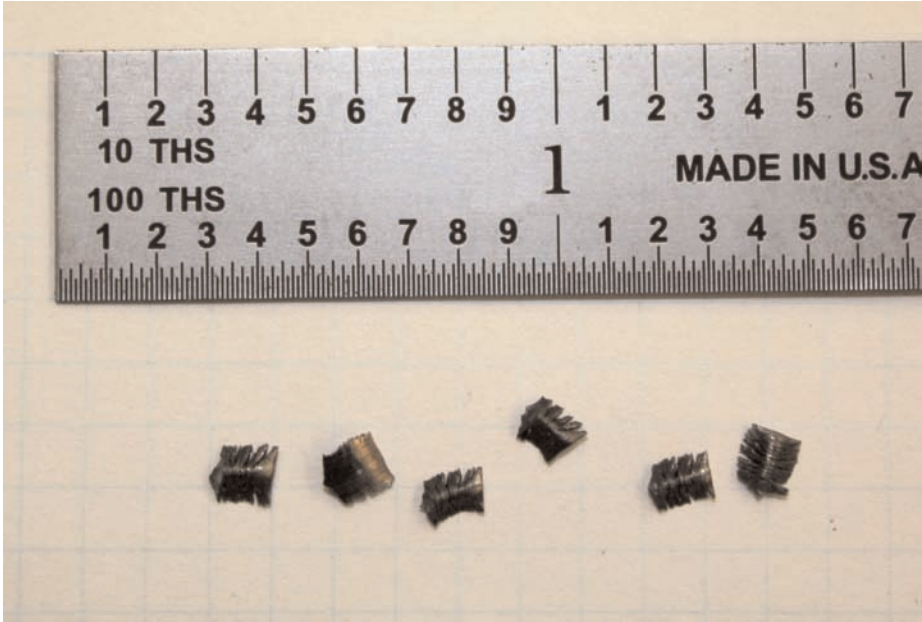
- (1) Burrs formed during the fabrication of the rotor shaft hex key socket may not have been removed at the time of manufacture. If present, the burrs could dislodge and enter the crankcase.
- (2) Advise the field of this condition and require an inspection for and removal of any burrs found in the rotor shaft hex key socket.
- (3) Regulatory action is unknown.

Fig. 2 - Typical Burrs as Removed from Hex Key Socket

- (b) Using a ball peen hammer, lightly tap the hex stock tool two or three times, then remove hex stock tool.
  - (c) Remove loose burrs with an awl or equivalent. Capture loose burrs and discard.

- (d) After the loose burrs are removed, visually inspect the alternator rotor shaft hex key socket again to assure all burrs have been removed. If any burrs are present repeat steps (a) through (d).
