Service Bulletin

Bulletin No. 040 A

Issue Date: Dec. 22, 2010

TURBOCHARGER CHRA CONTAMINATION

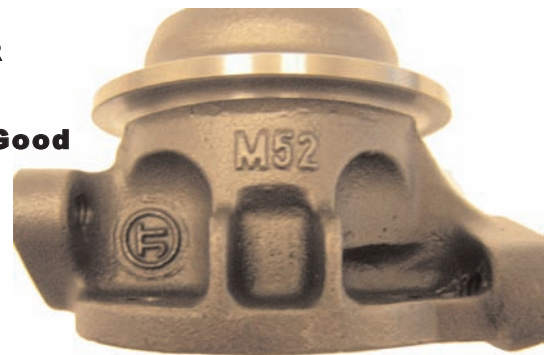
Figure 3 - Foundry Mark "JT"

3. Using Figures 2, 3, and 4, identify the foundry mark located on the CHRA center housing as shown. Those with a circled "JT" are not affected and may proceed to the "Return to Service" section step 3 & 4. If a "slanted A" appears, continue with the DISASSEMBLY and CLEANING sections.

Good

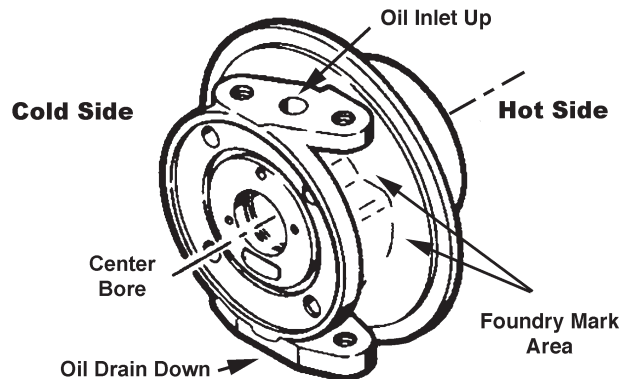
Figure 4
Typical CHRA
Center Housing

Hartzell Engine Technologies LLC (HET) has become aware of a condition affecting certain turbocharger center housing rotating assemblies (CHRA) where debris may not have been removed after the machining operation. The debris could enter the normal oil flow to the turbine wheel shaft assembly resulting in seizure of the shaft and/or turbine wheel head separation. This condition may also lead to a loss of engine oil. Either condition may lead to a complete loss of turbocharger function without warning as well as a partial or complete loss of engine power. Since this debris is expected to enter the oil stream quickly, the effects listed above can also occur quickly. The instructions herein identify the two manufacturing sources for the CHRA center housings of which only one is affected.

- Wearing protective Rubber Gloves, place CHRA center housing (Figure 4) into the bucket and soak for a minimum of 30 seconds. If the housing has coking or other stubborn deposits, allow to soak longer.

- After soaking, agitate center housing by hand in the bucket for a minimum of 15 seconds in each of the following directions: Center bore vertical, cold side down, center bore vertical, cold side up, oil drain down, and oil drain up. *Reference points shown in Figure 4.*

- Using the large nylon bristle brush, insert into center bore and oil outlet cavity. Scrub for 3 seconds minimum. Using the small nylon bristle brush, insert into the oil inlet and drain cavities. Work brush around the edges inside the cavity where chips and burrs may be located.
