# Service Information Letter

## Letter A-142

### **Turbocharger Installation and Turbine Housing Mounting Tab Shim Washers**

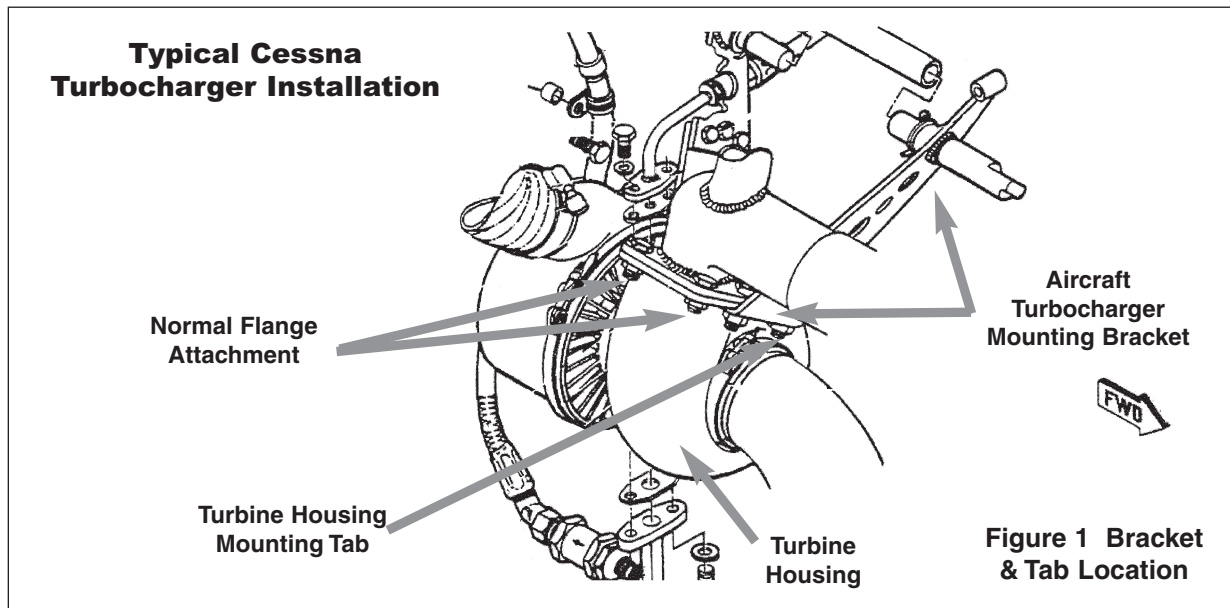
- (4) Begin the turbocharger installation per instructions found in the applicable section of the aircraft maintenance manual.
  - (a) Locate the interface between the aircraft turbocharger mounting bracket and the turbine housing mounting tab on the turbocharger installation. Refer to Figure 1.

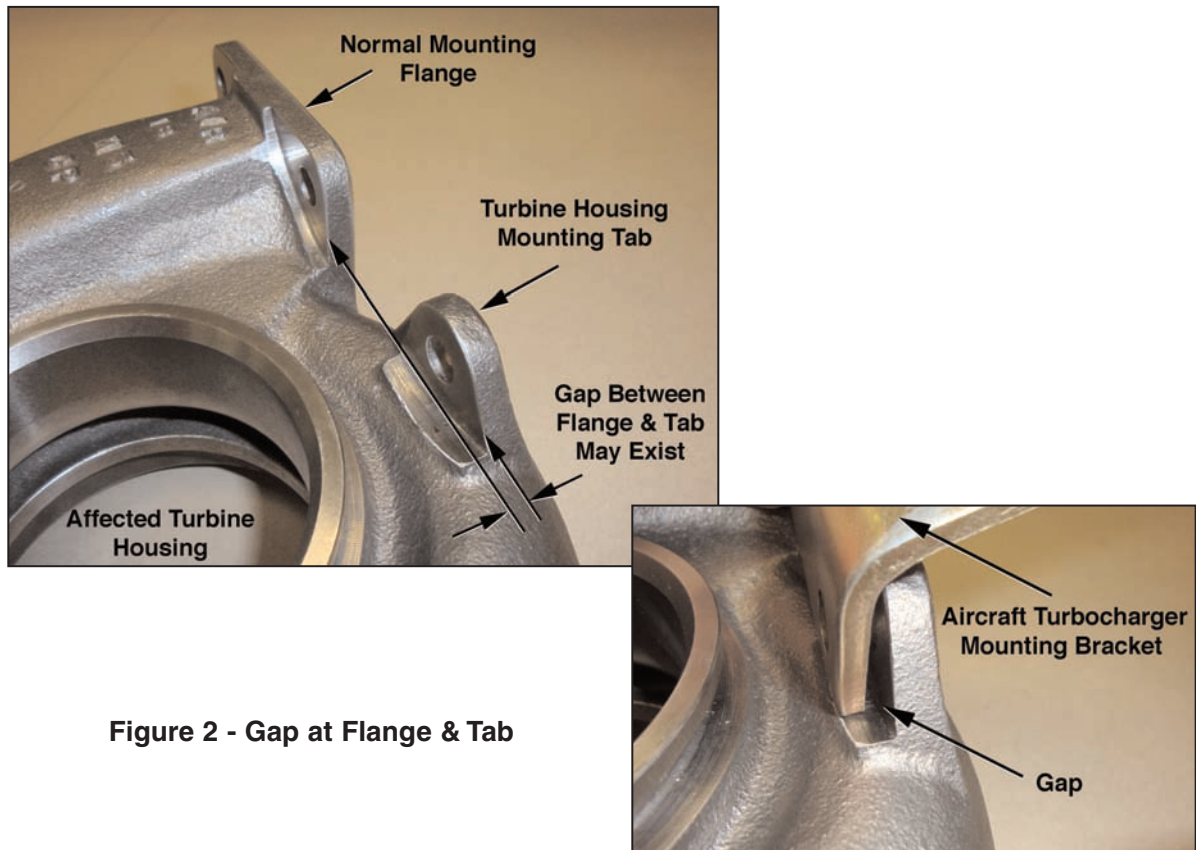
Figure 2 - Gap at Flange & Tab

- (5) Identify if a gap exists in the installation.
- (a) The example in Figure 2 shows a removed turbine housing which has the turbine housing mounting tab location condition. Identify the turbine housing mounting tab location with respect to the normal mounting flange face. The tolerances in the machining of the turbine housing mounting tab (as well as other installation tolerances) may generate a gap that varies in size.

- (1) When installing the turbocharger, observe the initial fit of the turbine housing to the aircraft turbocharger mounting bracket. A gap at the turbine housing mounting tab to aircraft turbocharger mounting bracket must not exceed 0.015 inch.

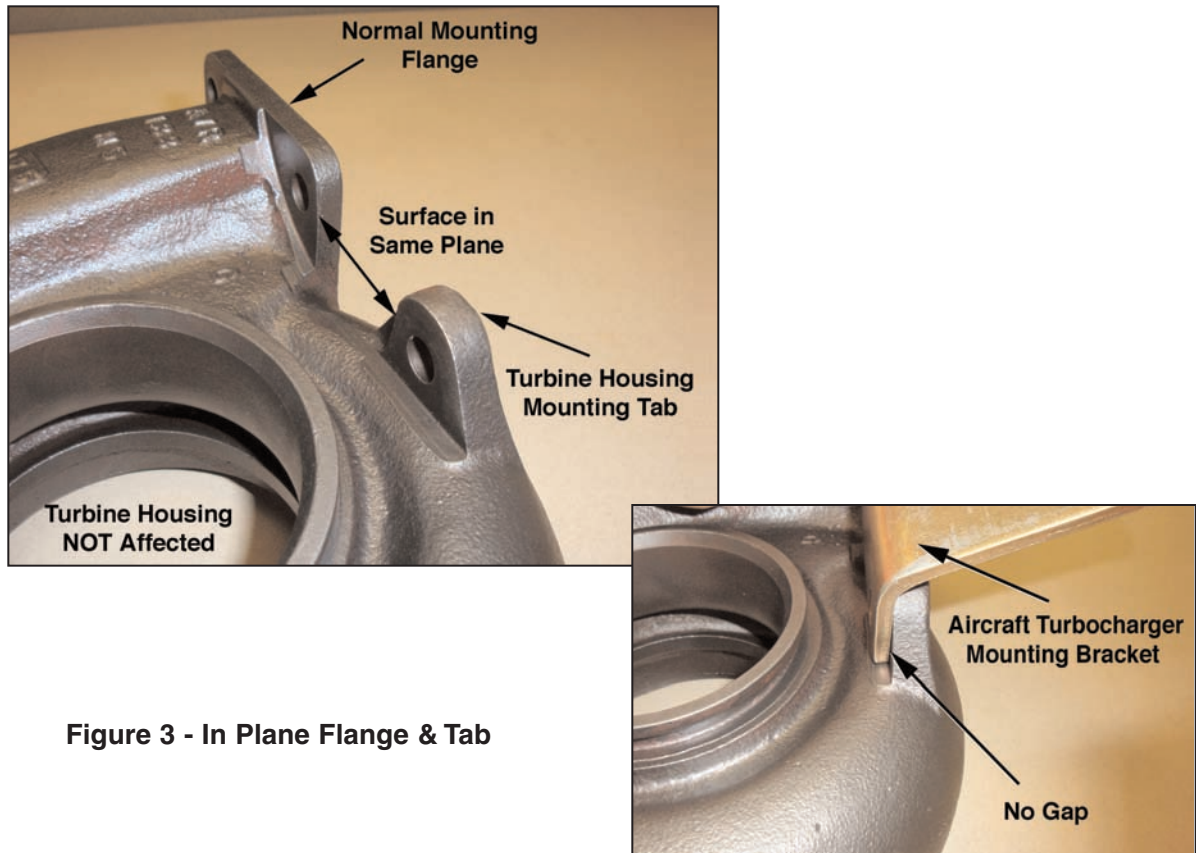
**Figure 3 - In Plane Flange & Tab**

- (2) If the initial fit of the turbine housing to the aircraft turbocharger mounting bracket shows a gap 0.015 inch or less, continue with the normal installation procedures per the applicable section of the aircraft maintenance manual. See Figure 3.
  - (a) Upon successful completion of the aircraft turbocharger installation, proceed to "Return to Service" 3.D.(1).
- (3) If the initial fit of the turbine housing to the aircraft turbocharger mounting bracket shows a gap that exceeds 0.015 inch, continue with 3.C.(1)
