Service Information Letter

Letter No. A-125 Rev. A

ES-6000 & ES-7000 SERIES ALTERNATOR TERMINAL CONNECTION INSTRUCTIONS

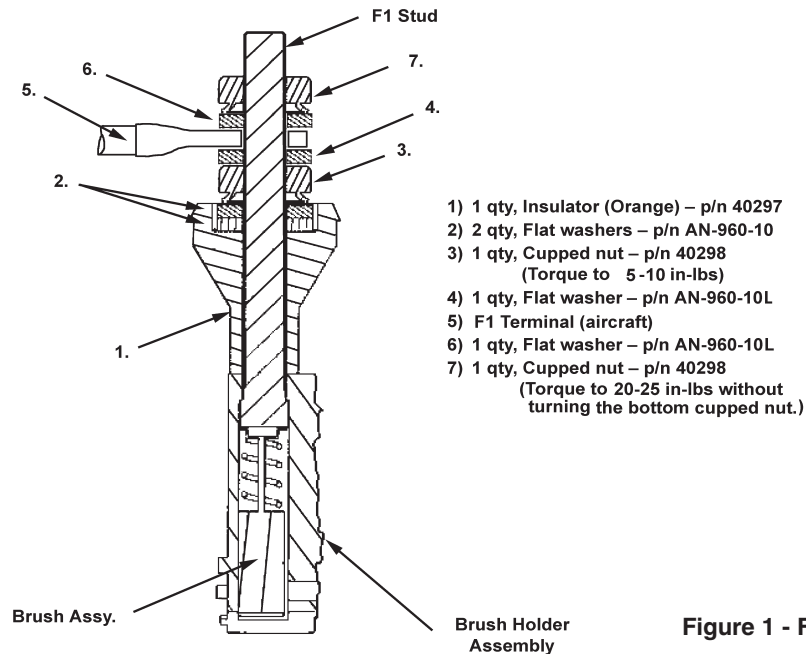
Figure 1 - F1 Terminal

It has come to the attention of Kelly Aerospace Power Systems that some guidance is needed when connecting aircraft or rotorcraft electrical wiring to the ES-6000 & ES-7000 series alternators. This is based on reports of loose battery (B) and field (F1) terminals. Overtightening or improper tightening may contribute to the condition or further maladies.

3. Locate the field terminal "F1" (orange insulator). Remove hardware and insulator. Inspect the insulator for cracks or signs of "mushrooming" on the bottom. Replace insulator if damaged.
4. Install the orange insulator (1) and two flat washers (2). Install cupped nut (3) and torque to 5 - 10 inch-pound. (0.56 - 1.12 N-m) Refer to Figure 1.
5. Install flat washer (4), aircraft field "F1" terminal (5) and flat washer (6). Install cupped nut (7) and torque to 20 - 25 inch-pound. (2.26 - 2.83 N-m) **It is imperative that the bottom cupped nut be held in place while the top cupped nut is being torqued to prevent damage or under torque. (Use a wrench of no more than .25 in. thickness on bottom nut.)** Refer to Figure 1.
