Service Bulletin No. 061

Alternator Model ALU-6539-4 Installation of Missing Spacer

- (1) Hartzell Engine Technologies LLC (HET) Alternator model ALU-6539-4 (Piper P/N 680-516) with serial numbers listed in Table 1 are affected by this Service Bulletin.
- (2) The affected alternators are used on Piper PA-46-350P Malibu Mirage and PA-46R-350T Matrix aircraft.

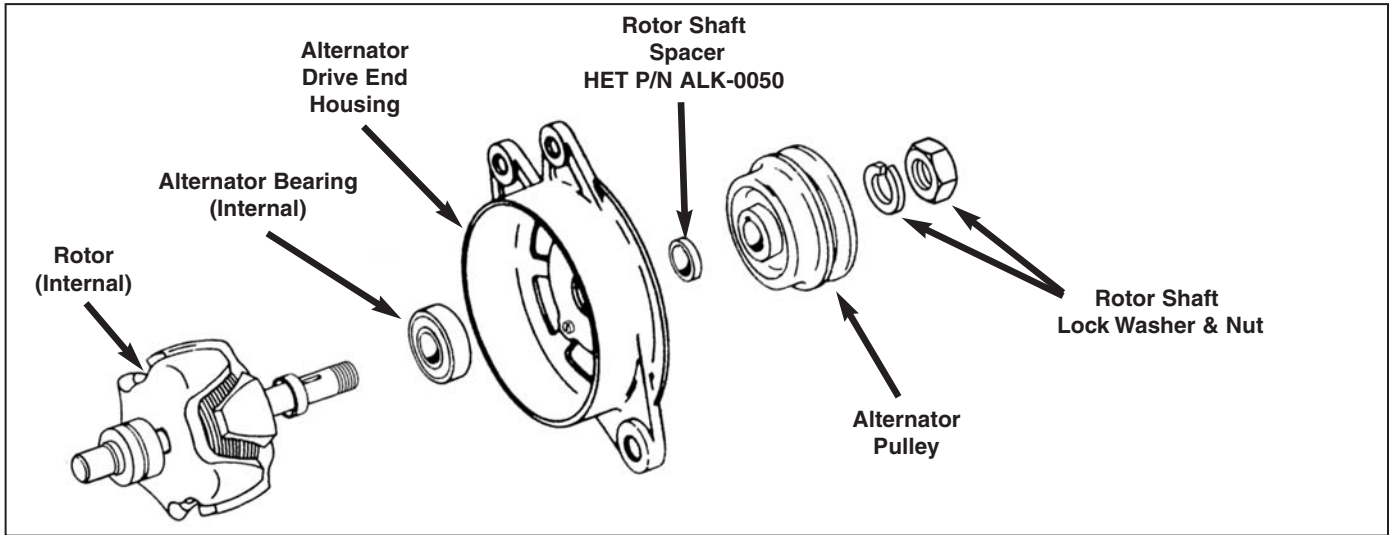
Fig. 1 - ALU-6539-4 Alternator Parts Position

- (1) Certain serial numbers of Alternator model ALU-6539-4 (Piper P/N 680-516) were shipped with the pulley installed, but were missing the HET P/N ALK-0050 spacer.
- (2) An HET P/N ALK-0050 spacer is required to be installed on the rotor shaft of the affected alternators.
- (3) Regulatory action is unknown.

- a. If damaged, the woodruff key will require replacement before the pulley is reinstalled.
- (9) Place the HET P/N ALK-0050 spacer on the rotor shaft sliding the notch over the woodruff key. Refer to Figure 1.

- (10) Install the pulley, lockwasher, and nut.
 - a. Using an appropriate size wrench on the nut-top spark plug socket hold the pulley nut in place.
 - b. Use the ratchet wrench with the 5/16 inch hex key tool to turn the rotor shaft counter-clock wise to tighten the nut. Refer to Figure 1.
