Service Bulletin No. 062

Alternator Models ALU, ALX & ALY Series HET P/N ALA-0020G Through Bolt Replacement

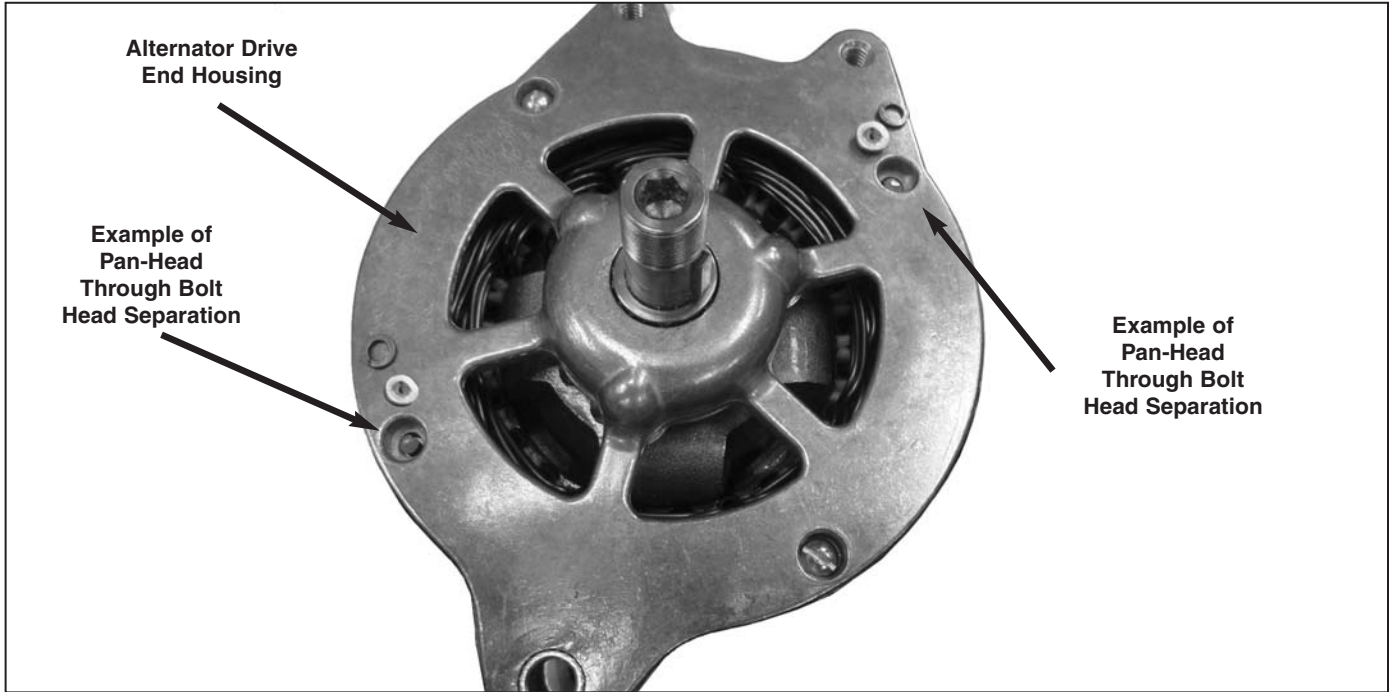
- (1) Affected serial numbers of alternator model ALU, ALX, and ALY may have a pan-head style HET P/N ALA-0020G through bolt installed. These pan-head through bolts have had incidences of bolt head separation. Refer to Figure 1.
- (2) To eliminate the risk of through bolt head separation, all pan-head through bolts must be replaced with HET P/N ALA-0020G fillister-head style through bolts on the affected alternators. Refer to Figure 2 and Figure 3.
- (3) The pan-head version of the HET P/N ALA-0020G through bolt is being discontinued and will no longer be used.
- (4) Regulatory action is unknown.

Figure 1 - ALX-8521LS Pan-Head Through Bolt Head Separation Example Shown with Fan Removed.

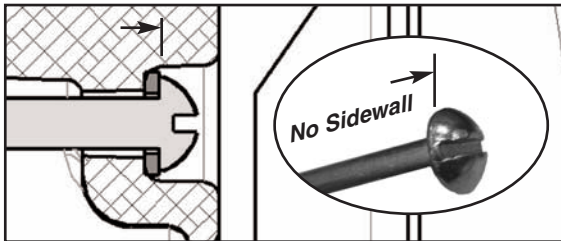
Figure 2 - Pan-Head Through Bolt (If found alternator must be repaired)

- a. If a pan-head through bolt is installed, return the affected alternator to HET for repair per 3.C Corrective Action. Refer to Figure 2.
 - b. If positive identification that four fillister-head through bolts are installed, the affected alternator is in compliance with this service bulletin. Proceed to 3.D(3), Return to Service. Refer to Figure 3.

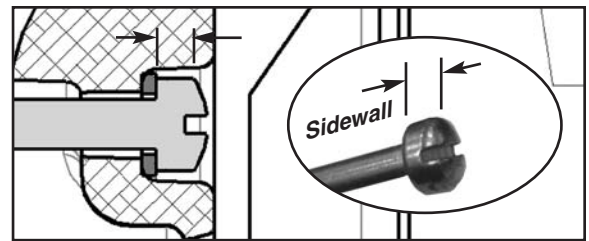
Figure 3 - Fillister-Head Through Bolt (If four found, alternator is acceptable)

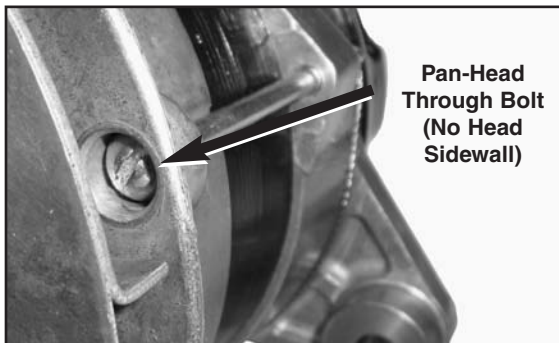
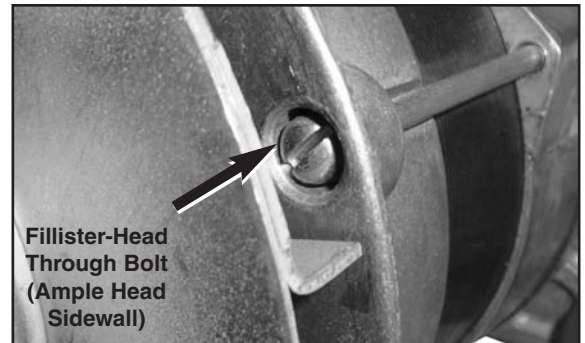
Figure 4 - Through Bolt Head Inspection Example Shown.

- B. Inspection:
 - (1) Using a bright white light, inspect the alternator drive end housing at each through bolt location (four each) beneath the fan. Refer to Figure 4.
