Service Bulletin

Service Bulletin No. 063

Alternator Models ALT Belt & ALX Gear Series HET P/N ALA-0020G Through Bolt Replacement

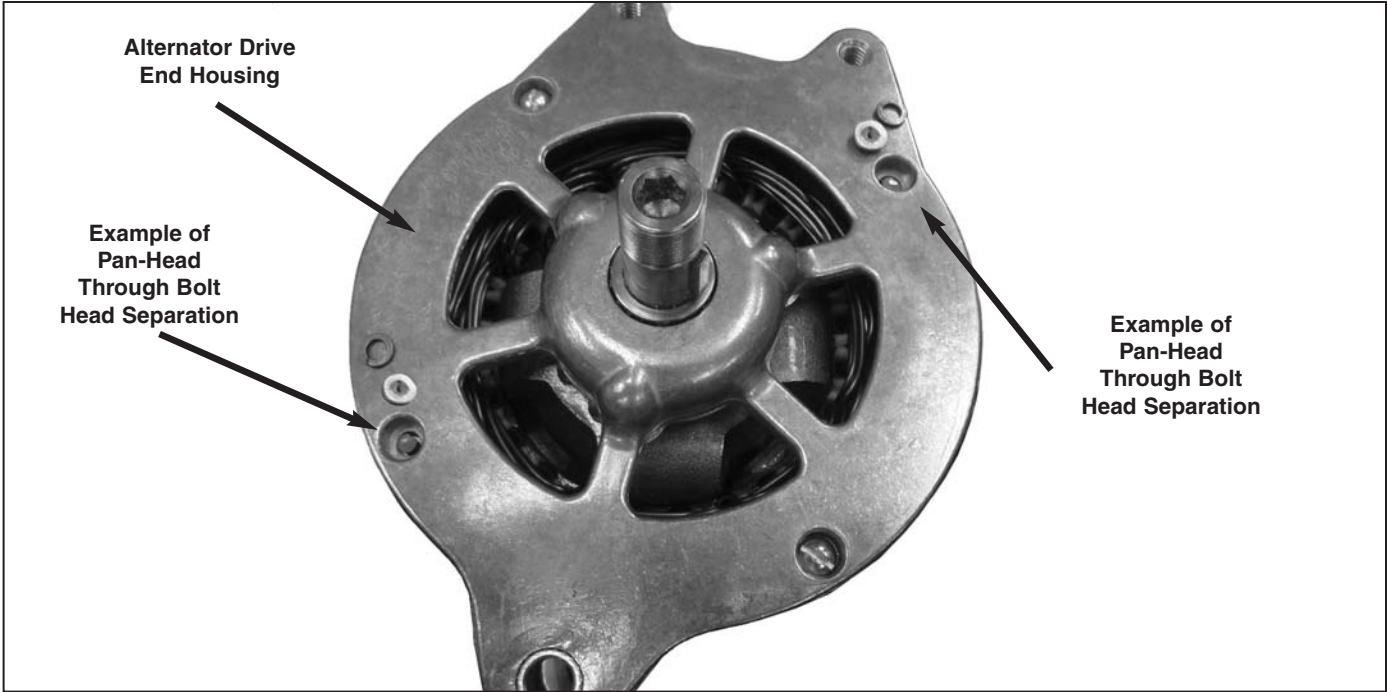
- (1) Affected serial numbers of model ALT and ALX series alternators may have a pan-head style HET P/N ALA-0020G through bolt installed. These pan-head through bolts have had incidences of bolt head separation. Refer to Figure 1.
- (2) To eliminate the risk of through bolt head separation, all pan-head through bolts must be replaced with HET P/N ALA-0020G fillister-head style through bolts on the affected alternators. Refer to Figure 2, Figure 3, and Figure 5.
- (3) The pan-head version of the HET P/N ALA-0020G through bolt is being discontinued and will no longer be used.
- (4) Regulatory action is unknown.

Figure 1 - Belt Drive Alternator Pan-Head Through Bolt Head Separation Example (Shown with Fan Removed)

- (1) This Service Bulletin provides Instructions for Continued Airworthiness (ICA).
- (2) This Service Bulletin requires an inspection of the affected alternators shown in Table 1 and return of any that are found to have pan-head through bolts installed.
 - a. The alternator will be repaired using HET P/N ALA-0020G fillister-head through bolts.

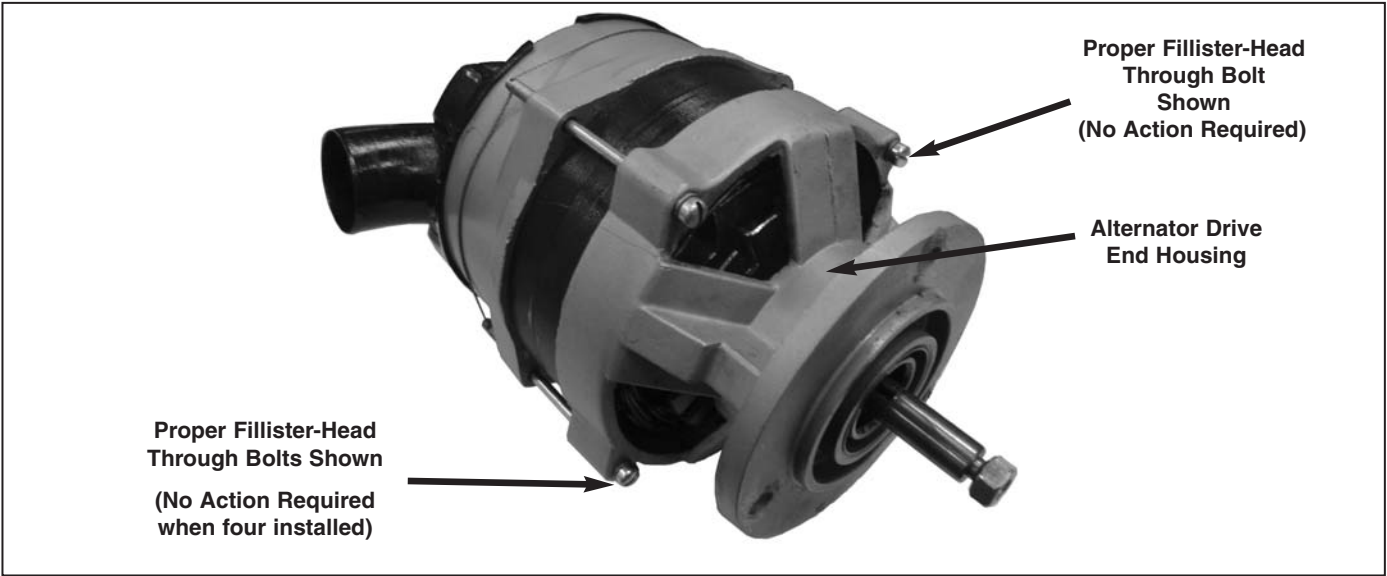
Figure 2 - ALX-9525BR Proper Fillister-Head Through Bolt Example for Gear Drive.

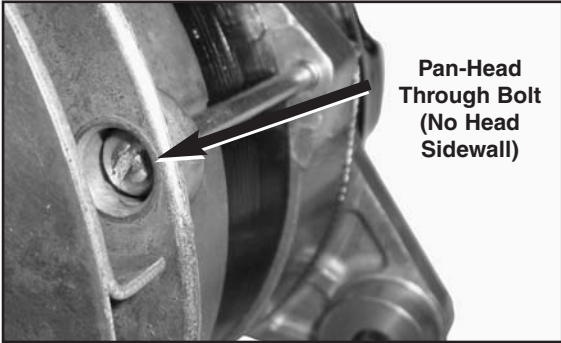
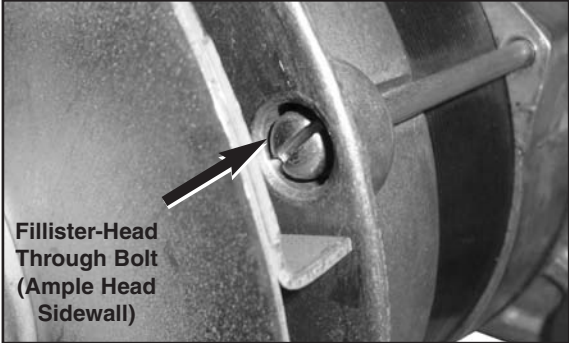
Figure 3 - Through Bolt Head Inspection Example for Belt Drive Shown.

- (1) Using a bright white light, inspect the alternator drive end housing at each through bolt location (four each). Refer to Figure 2 and Figure 3.
 - a. If a pan-head through bolt is installed, return the affected alternator for repair per 3.C, Corrective Action. Refer to Figure 4.
 - b. If positive identification that four fillister-head through bolts are installed, the affected alternator is in compliance with this service bulletin. Proceed to 3.D(3), Return to Service. Refer to Figure 5.

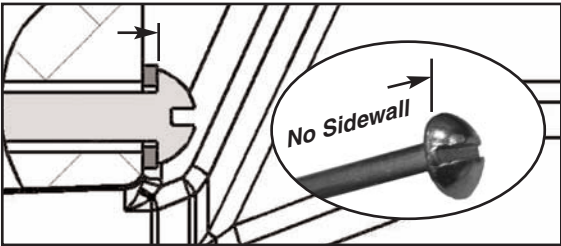
Figure 4 - Pan-Head Through Bolt (If found alternator must be repaired)

- a. Remove affected alternator from the engine per the applicable aircraft and/or engine maintenance manual or service instruction.
- b. Return all affected alternators directly to HET for repair per section 4 Contact Information.
 - (i) Include the completed SB 063 Claim form found in the Commercial Appendix attached to this Service Bulletin along with the HET supplied RMA number.

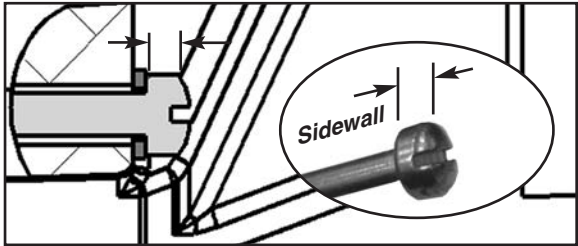
Figure 5 - Fillister-Head Through Bolt (If four found, alternator is acceptable)
