Service Bulletin No. 064

Alternator Model ALV-9610 Series Through Bolt Inspection for Proper Torque

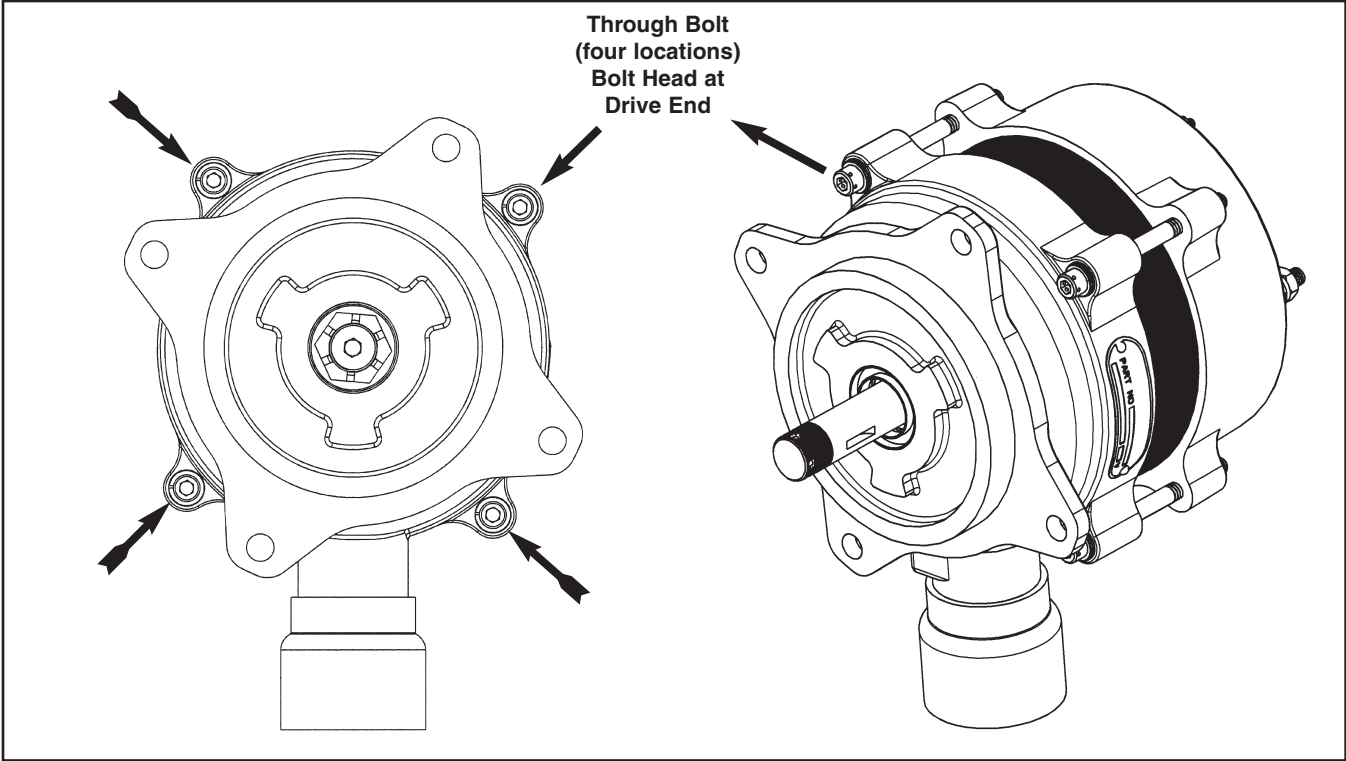
Figure 1 - Typical ALV-9610 Alternator

- (1) Affected alternator model ALV-9610 may have a condition where the flat washers under the through bolts impinge upon a cast fillet radius in the alternator housing through bolt boss. This condition may result in loss of through bolt torque.
- (2) An inspection to determine applicability of the ALV-9610 alternator and re-torque of each of the four through bolts if applicable, is required.
- (3) Regulatory action is unknown.

- (1) Remove the safety wire or safety cable from the head of the through bolts of the affected alternator. Refer to Figure 1.

- (2) Using a 3/16 hex stock tool, torque the through bolts to 45 to 50 in-lbs one at a time in a cross pattern using a calibrated torque wrench.
- (3) Properly install .032 inch stainless steel safety wire or optional Safety-T-Cable™, HET P/N RX-1961 at the head of the through bolts. Tool requirements and Installation information for Safety-T-Cable™ may be found at <http://www.dmctools.com>.
