Service Bulletin No. 065

201F Fuel Pump

Valve Housing Cap Screw Replacement

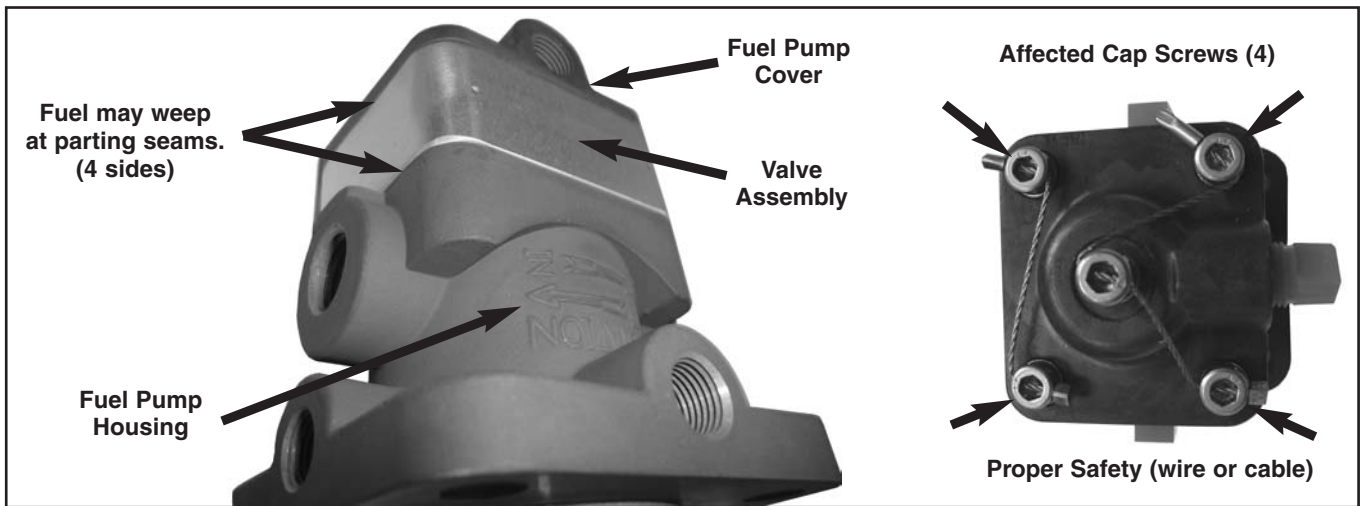
Figure 1 - 201F Fuel Pump Component Identification

- (1) Fuel weepage at the fuel pump valve housing parting seams has been observed. This condition may be due to the cap screws bottoming out before reaching full clamping load.
- (2) If fuel weepage exists at the valve housing, fuel dye stains may appear at the upper and lower seam where the cover, valve, and pump housing meet.
- (3) Replacement of the four (4) existing pump assembly cap screws part number NAS1352C3H22 with four (4) shorter cap screws part number NAS1352C3H20 is required.
- (4) Regulatory action is unknown.

- (6) Install .032 inch stainless steel safety wire or optional Safety-T-Cable™, HET P/N RX-1961 at the head of the cap screws. Tool requirements and Installation for Safety-T-Cable™ may be found at <http://www.dmctools.com>. Refer to Fig. 1.
