Service Bulletin No. 066

Gear Driven Alternator Rotor Replacement HET Models ALX-9522, ALX-9524, & ALT-9522

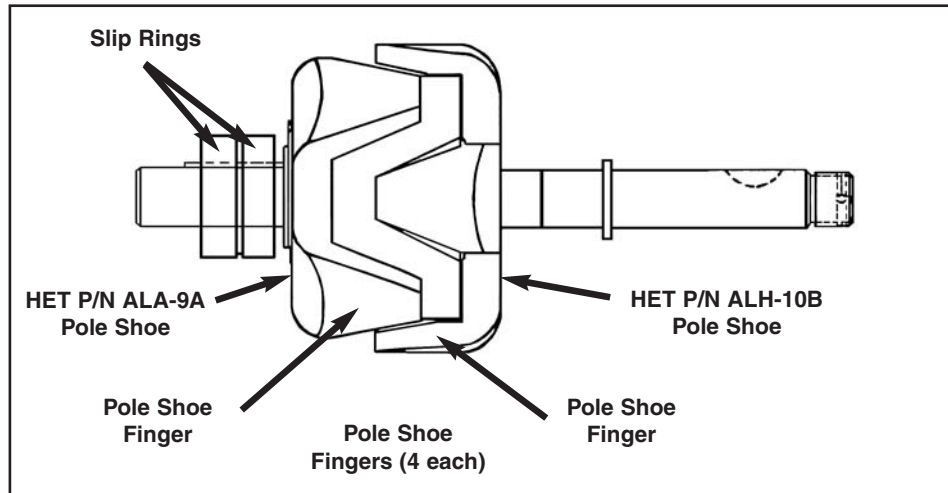
- (1) The suspect serial numbers of alternator models ALT-9522, ALX-9522, and ALX-9524 have rotor assemblies that contain pole shoes ALA-9A and ALH-10B that may fracture during normal operation.
- (2) Fracture of the pole piece fingers may result in rotor seizure. Refer to Fig. 1.
- (3) Regulatory action is unknown.

Figure 1 - Typical Rotor Assembly
(ALH-2238S-1, ALU-2238S-1, or ALX-2238AS-1)

- (1) This Service Bulletin provides Instructions for Continued Airworthiness (ICA).
- (2) This Service Bulletin requires factory inspection/repair or field replacement of suspect rotors in affected alternators.
- (3) This Service Bulletin requires factory inspection/replacement of suspect piece part rotors.

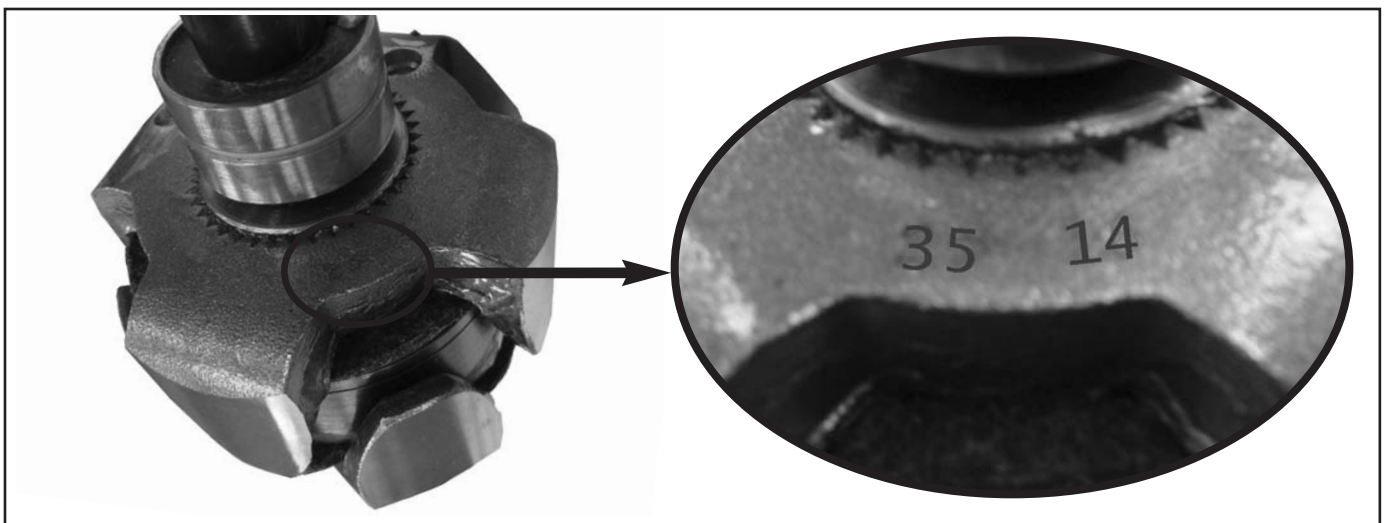
**Figure 2 - Suspect Rotor Identification,
Date Codes - 35 14 through 18 16 (week, year format)**

- A. ALX-9522, ALX-9524, and ALT-9522 alternators with serial numbers listed in Table 1.
- B. Rotors and kits with date code stamp 35 14 through 18 16 (week, year format) or that were delivered between September, 2014 through May, 2016.
 - (1) Includes alternators documented to contain affected rotors through field overhaul or repair.

NOTE: Suspect rotors may be returned to the HET factory for inspection to determine if the rotor is affected. Suspect rotors not inspected by HET are considered affected. Factory inspected rotors in the date code range listed in 1.A(2) Effectivity that are not affected will have an "X" stamped after the date code.
