Service Bulletin No. 068

Jasco Alternator Wire Harness Wire Chafing Protection or Replacement

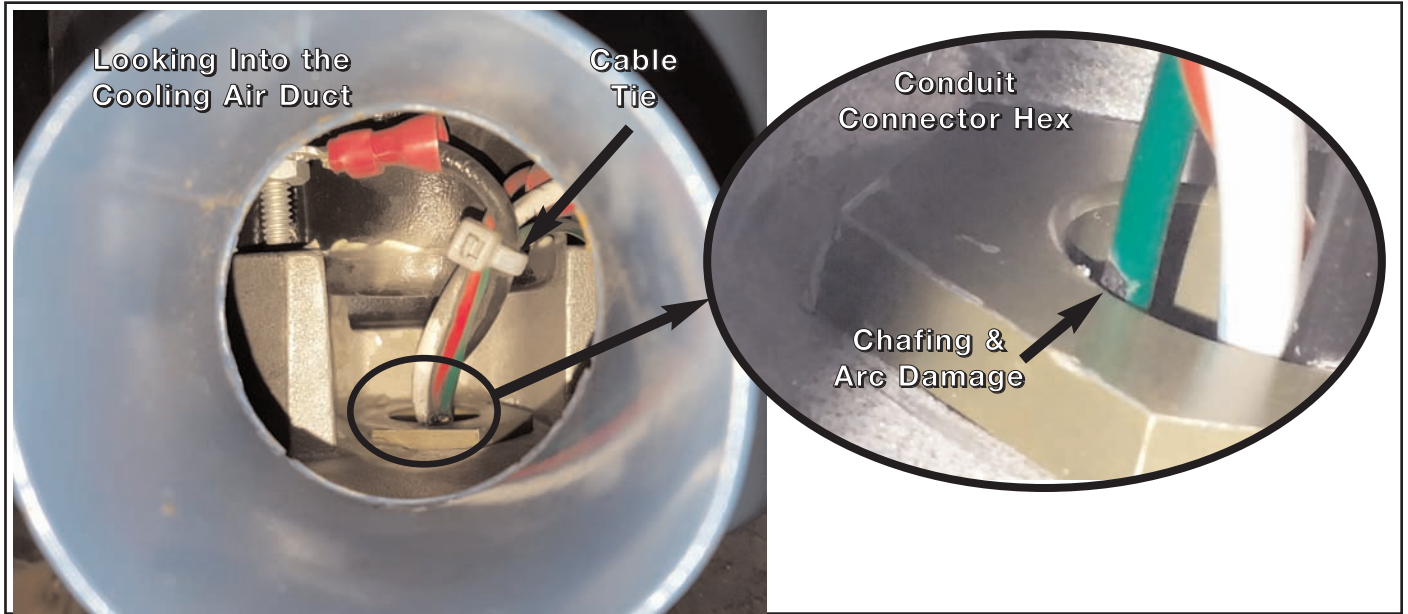
- (1) All Jasco alternator models with serial numbers per the Effectivity above may experience a chafing condition of the electrical harness during normal operation.
- (2) A chafing condition of the electrical harness may result in electrical arcing, tripped circuit breaker, and loss of alternator function. Refer to Fig. 1.
- (3) Regulatory action is unknown.

Figure 1 - Wire Harness Chafing Condition

- (a) The chafing protection is a two inch piece of .375 inch PTFE spiral insulation that must be wrapped around all four wires of the wire harness. Refer to Fig. 3.

- (10) Wrap the spiral insulation over the four wires using a screw action, inserting it until the spiral insulation seats against the cable tie and passes the area of the conduit connector where chafing may occur.

- (a) Tighten the spiral insulation wrap to limit any gaps. Refer to Fig. 1 and Fig. 3.
 - (11) Push the knurl collar with retained grommet along the wire harness to the conduit connector.

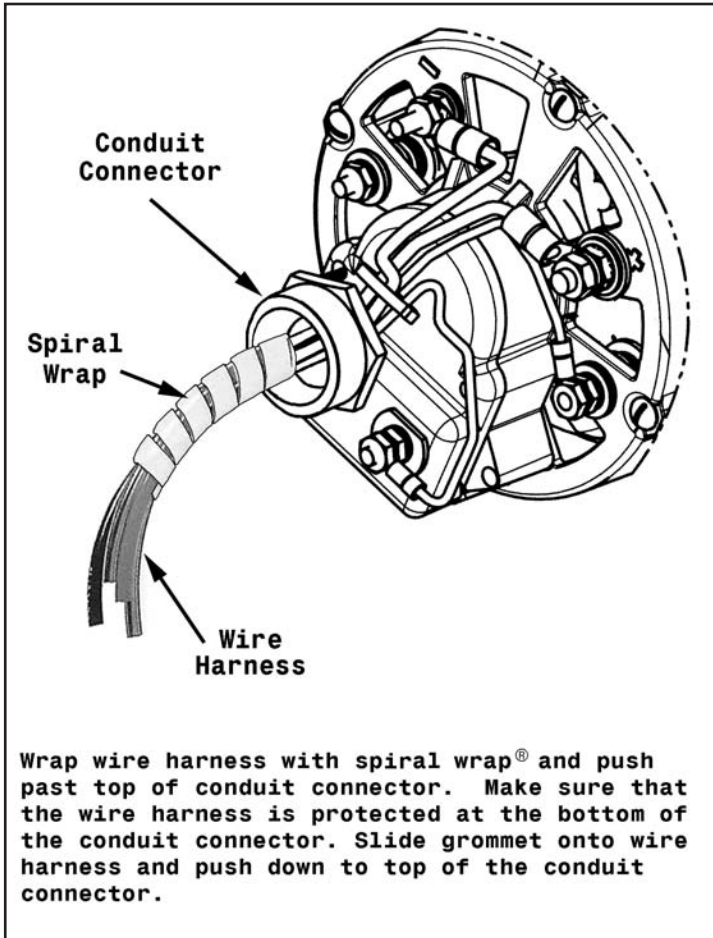
Figure 3 - Spiral Insulation Example

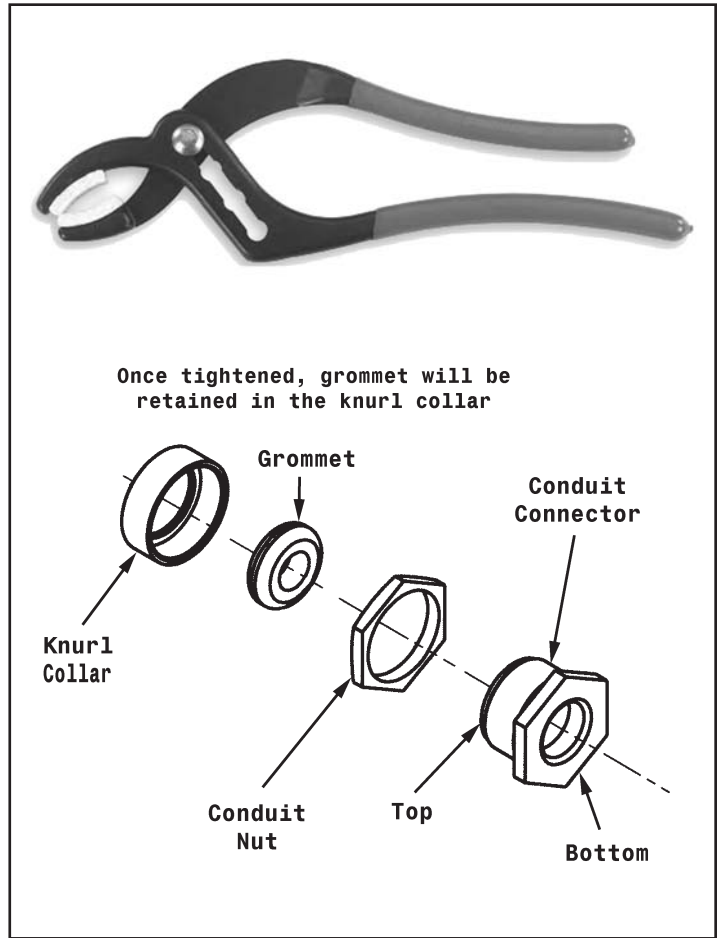
Figure 4 - Soft Jaw Connector Plier & Connector Stack Up

- (8) Using a soft jaw connector plier, loosen the knurl collar completely. Refer to Fig. 4.
 - (9) Move the knurl collar with retained grommet away from the conduit connector down the wire harness to allow room to install the chafing protection. Refer to Fig. 2 and Fig. 3.

- (12) Thread the knurl collar onto the conduit connector.
 - (a) Tighten the knurl collar finger tight then 1/4 turn more. Refer to Fig. 4.
 - (13) Install each wire on the terminal strip stud that corresponds to the color of the wire and the color listed on the placard above the terminal strip. Refer to Fig. 2.

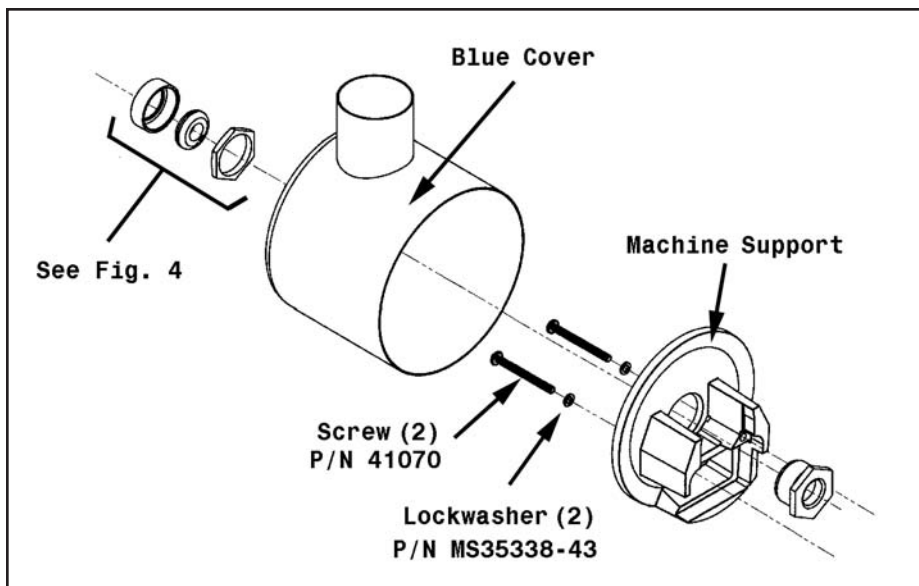
Figure 5 - Machine Support Removal

- (a) Thread the green AUX wire through the conduit connector and connect it to the stud.
 - (b) If torque of the green AUX wire nut cannot be achieved, it is permissible to remove the machine support by removing the two HET P/N 41070 screws and lockwashers. Refer to Fig. 5.
