Service Bulletin

Bulletin No. 040 A

Issue Date: Dec. 22, 2010

TURBOCHARGER CHRA CONTAMINATION

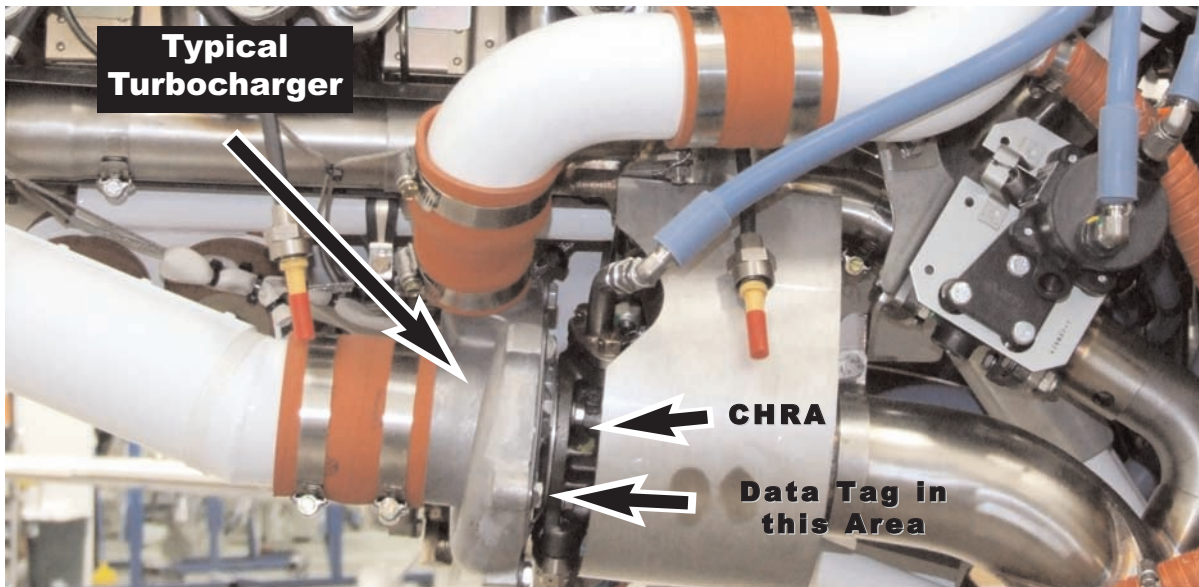
Figure 1 - Typical Turbo Installation

2. Refer to Table I to determine if the turbocharger being inspected is an affected part number. Observe the part number found on the data plate. If the affected part number **does not** appear, go to the "Return to Service" section step 3 & 4. If an affected part number **does** appear, continue with step 3. (See Figure 1 for typical turbocharger installation.)
